RE: "ST ELIZABETH CHURCH" AAA JOB #25528
2700 E BALTIMORE ST BALTIMORE, MARYLAND

ST ELIZABETH CHURCH – RENOVATION PROJECT: VISUAL INSPECTION, BULK SAMPLING & LABORATORY POLARIZED LIGHT MICROSCOPY (PLM) ANALYSIS OF CLIENT AND OWNER SELECTED MATERIALS SUSPECT TO CONTAIN ASBESTOS

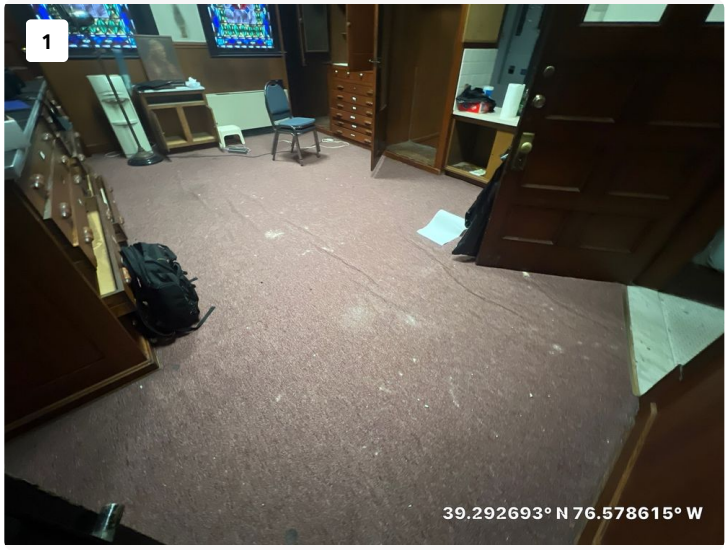
Carpet on padding not glued - First floor chapel east office
